TRANSMITTAL

COPIES	NUMBER	DESCRIPTION	CODE
1		FRP Fabrication NCR 7-2-1 - PE Seal per 8/22/14 Letter	H
1		FRP Fabrication NCR 7-2-1 - UT Testing & Warrantee per 8/22/14 Letter	H

Brookfield BRFLBR (2)

Brookfield BRF FLBR (2)

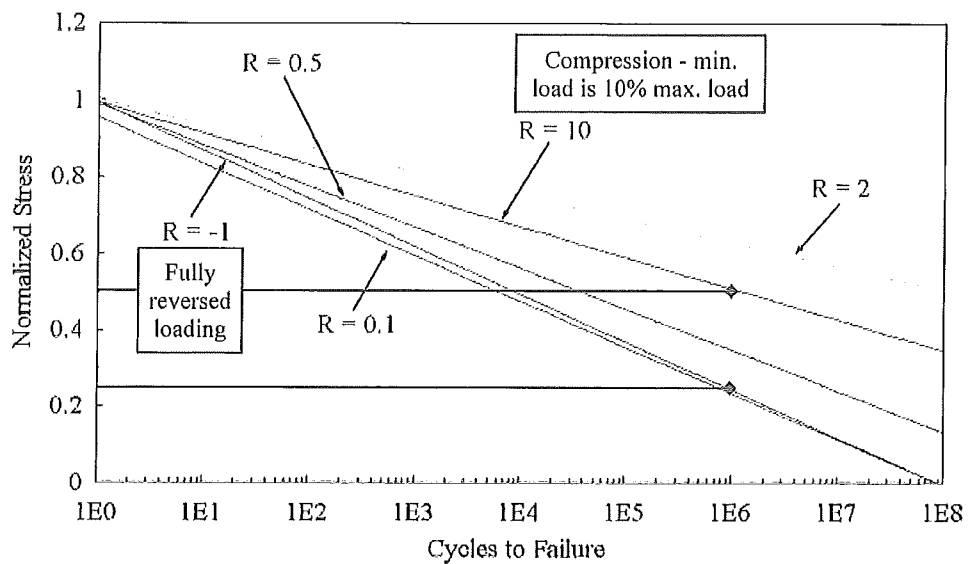
Figure 1 – Constant Amplitude S-N Fatigue Data¹

In order to empirically evaluate the long term effect of cyclic loading on the durability of the re-infusion, the direction and magnitude of applicable loads must first be defined. After reviewing the design, Kenway has determined that the quantifiable cyclic loads imparted on the repair areas will be due to ice loading where the load is one sided (compression only) or service loads where the load is fully reversed (tension and compression). Figure 1 shows curve fits to data for vinyl ester infused fiberglass specimens that have been exposed to fatigue loading. This shows that the laminate can be exposed to 50% of its ultimate compressive strength ($R = 10$) and 25% of its ultimate tensile strength ($R = -1$) and still reach 1 million cycles before failure. By comparison, the primary laminate in way of defects – completely ignoring the secondary infusion – will see 7% of the ultimate tensile strength and 2% of the ultimate shear strength.

- Quantifiable quasi-static stresses on the primary infused laminate – ignoring the secondary infusion completely – are well below the allowable design strengths as documented above.
- Quantifiable cyclical stresses on the primary laminate – ignoring the secondary infusion completely – and the anticipated number of cycles in service are orders of magnitude lower than documented S-N curves for vinyl ester/fiberglass laminate.

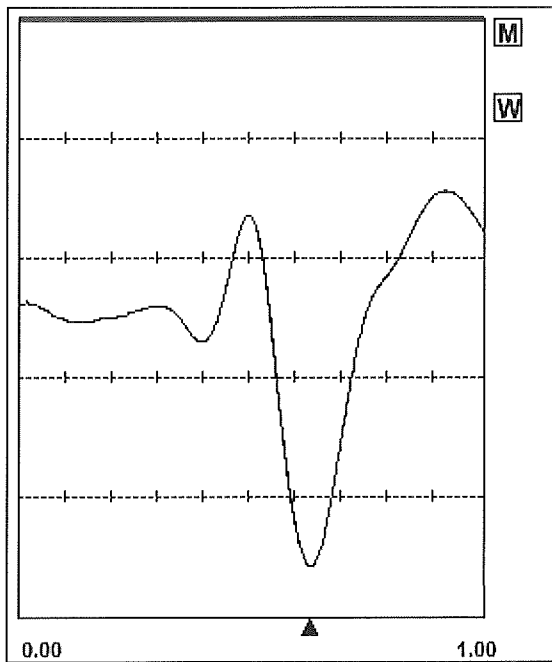
Point ID 1

Description: Primary infusion – typical thickness

UT Thickness: 0.628 in.

Caliper Thickness: 0.626

Indications: None

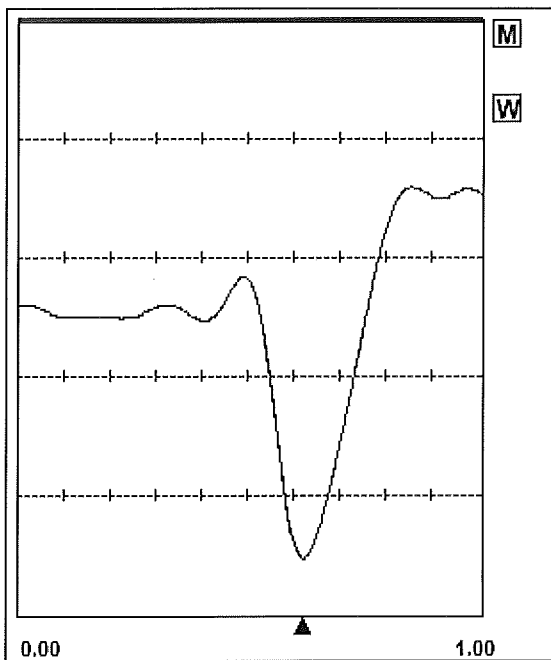
Point ID 2

Description: Radius side – West rod hole

UT Thickness: 0.615 in.

Caliper Thickness: 0.607

Indications: None

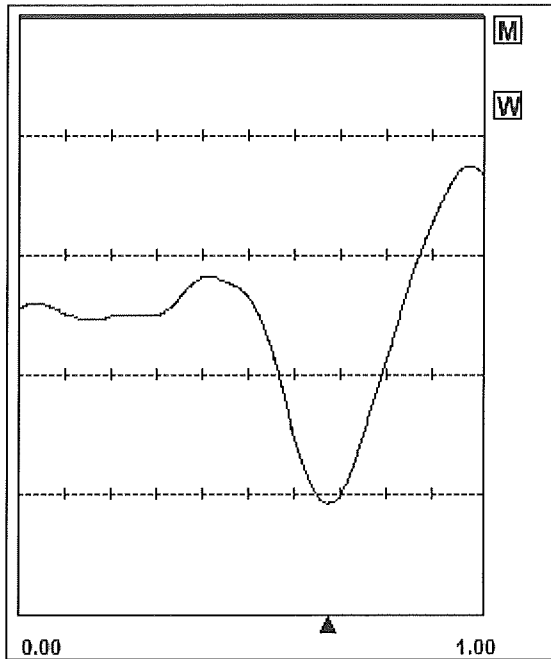
Point ID 3

Description: Radius side – middle rod hole

UT Thickness: 0.665 in.

Caliper Thickness: 0.659

Indications: None

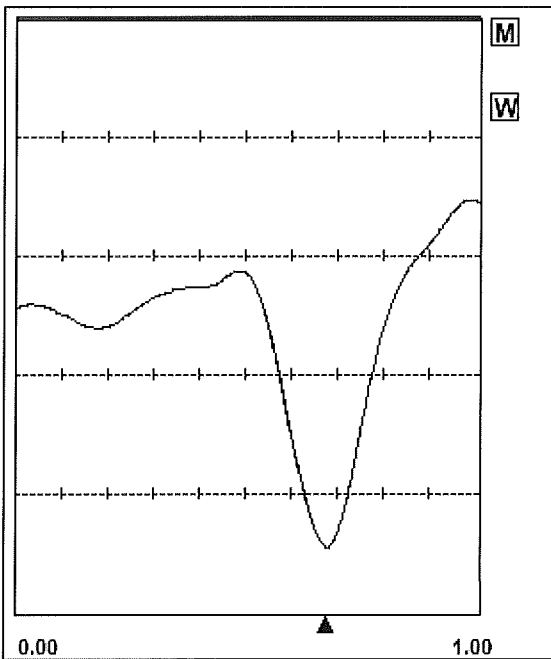
Point ID 4

Description: Radius side – East rod hole

UT Thickness: 0.670 in.

Caliper Thickness: 0.664

Indications: None

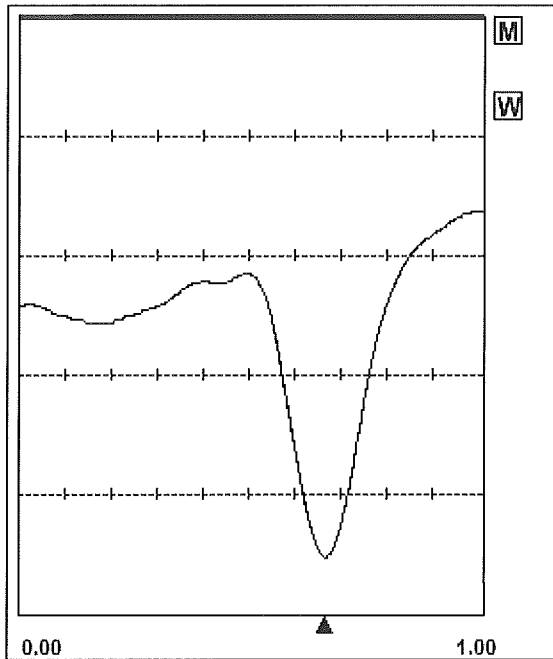
Point ID 5

Description: Vertical side – East rod hole

UT Thickness: 0.659 in.

Caliper Thickness: 0.657

Indications: None

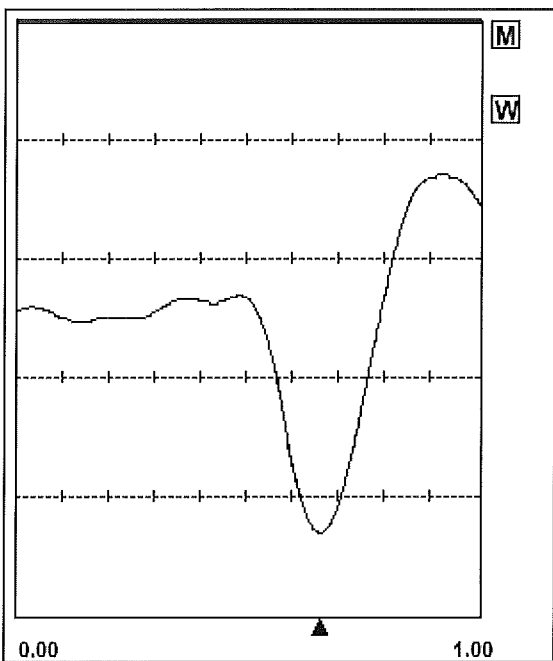
Point ID 6

Description: Vertical side – middle rod hole

UT Thickness: 0.655 in.

Caliper Thickness: 0.648

Indications: None

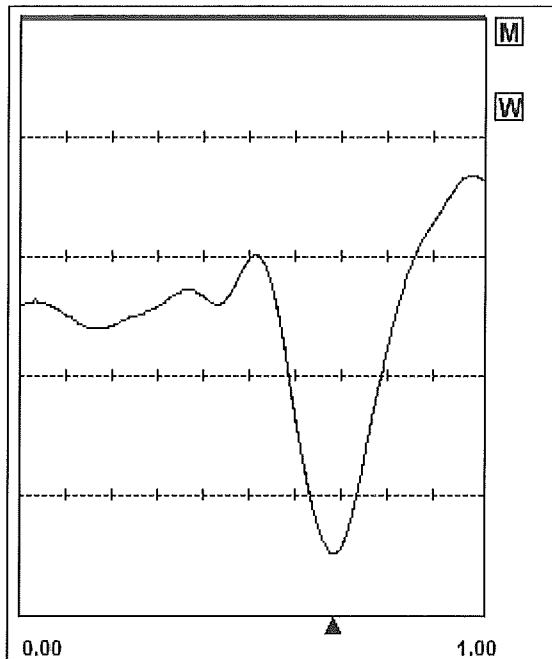
Point ID 7

Description: Vertical side – West rod hole

UT Thickness: 0.676 in.

Caliper Thickness: 0.672

Indications: None
